Essays and Perspectives

Fundão tailings dam failures: the environment tragedy of the largest technological disaster of Brazilian mining in global context

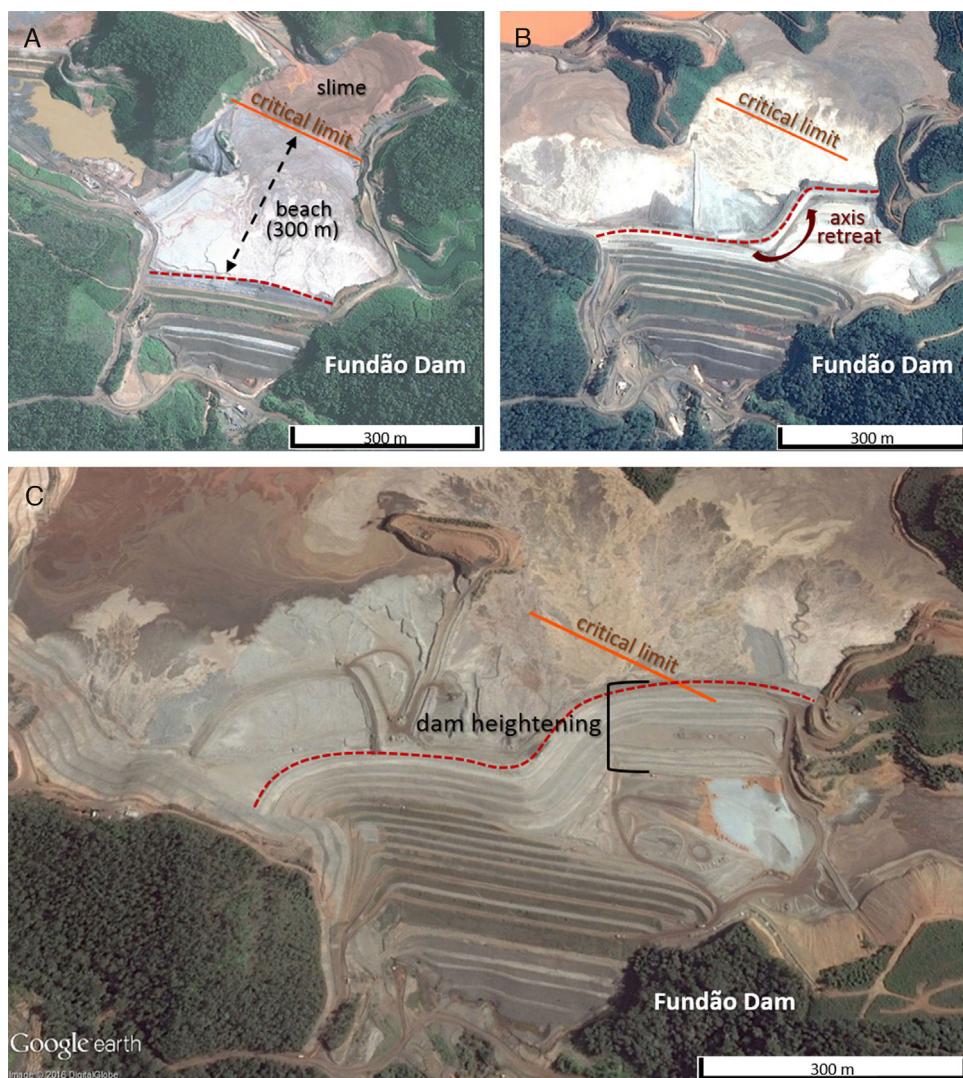
saturation of sandy material. In some situations, emergency measures were implemented ([Samarco, 2016b](#)), one of them known as retreat of the dam axis was begun in 2013. According to [Samarco \(2016b\)](#), the retreat represented: “... a temporary solution, it was decided to realign the dam on the left shoulder by moving it behind the section of the gallery to be filled with concrete, in order to allow the continuation of the landfill embankment.(...) The retreat would move the crest closer to the water of the reservoir and the mud contained within, but it was anticipated that the dam would quickly return to its original alignment once the buffering operations were done.”

However, the retreat was maintained until the collapse of the dam. According to [Samarco \(2016b\)](#): “As the dam embankment continued, surface upwellings began to appear at the retreat of the left shoulder at various elevations and on various occasions during 2013. The saturated mass with sandy tailings was growing, and in August 2014, the drainage carpet controlling this saturation reached its maximum capacity. Meanwhile, the mud under the landfill was responding to the increase in the load that was being deposited by the embankment. The way in which it responded, and the consequent effect on the sands, was what finally made the sands liquefy.”

Technical reports on the Fundão disaster ([Samarco, 2016b](#)) concluded that the collapse was due to liquefaction of the material, a phenomenon that occurs when solid materials (sandy tailings) lose their mechanical resistance and present fluid characteristics. Basically, the disaster occurred because of some key factors such as: structural damage to the starter dike, resulting in increased saturation; the attempt to solve structural problems with a concrete gallery that caused the axis of the dam to retract ([Fig. 1](#)), later being raised on mud; and the unforeseen deposition of sludge in critical regions. In upstream embankment dams, it is essential for the stability of the structure that the deposition of unsaturated sandy tailing create a beach, at least 200 m wide, immediately upstream of the dam crest.

Fig. 1. Fundão dam. (A) Formation of sandy tailings beach 300 m wide and upstream mud deposition, highlighting the critical limit of contact between sandy tailings and sludge (orange line), image of 2011. (B) Retreated axis for emergency works in a concrete gallery brings the crest closer to the critical limit of contact between sandy tailings and sludge (red dashed arrow), image of 2013. (C) Embankment of the dam displaced axis in the critical limit of contact between sandy tailings and sludge (orange line), 2015 image. Adapted from Google Earth Pro.

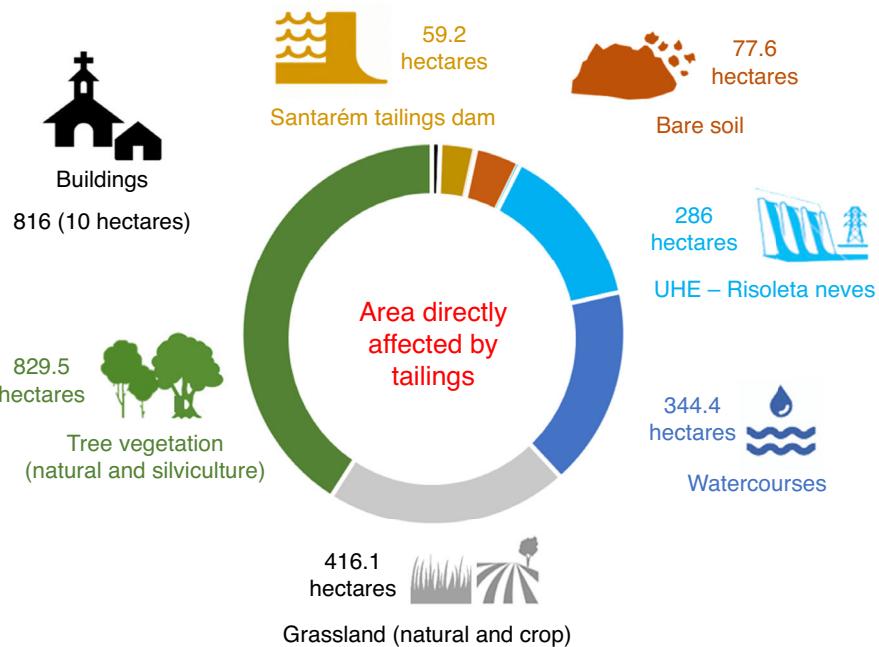
Areas of cultural heritage also suffered greatly. Damages include, at least two archeological sites, six places of historical and cultural interest, more than 2000 sacred pieces/material heritage, five caves, a 2.2 km stretch of the Estrada Real and preserved areas of the landscape complex in the junction of the Carmo and Piranga Rivers and the urban complex of Bento Rodrigues. One of the main cultural heritage assets irreversibly affected was the São Bento chapel, an 18th-century building surrounded by stone walls (Fig. 3 and Fig. S2).

Fig. 2. Elements of natural and cultural heritage damaged by the Fundão tailings dam.

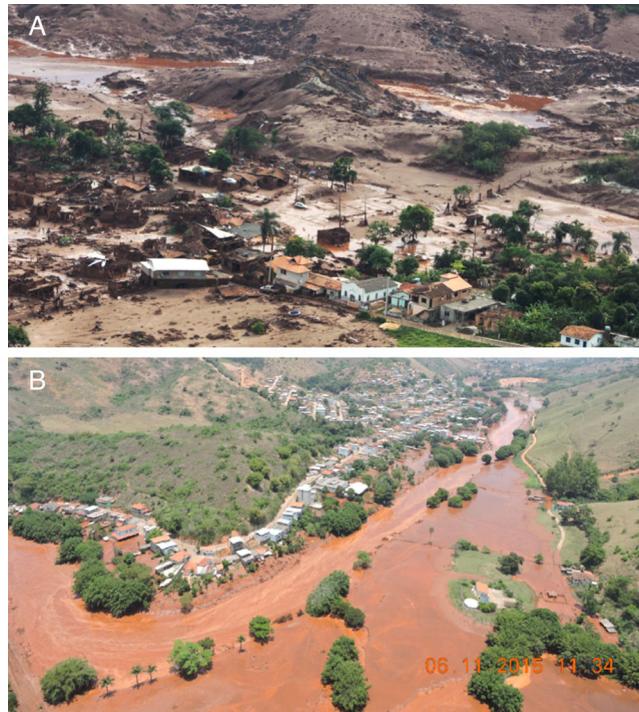
Out of the 806 buildings directly hit by the tailings, at least 218 were completely destroyed. These were residences, public buildings, commercial real estate, centennial churches and ancient farms distributed among 10 districts of five municipalities: Mariana, Barra Longa, Ponte Nova, Santa Cruz do Escalvado and Rio Doce. Bento Rodrigues, just 6 km from the Fundão dam, was the most damaged district with 84% of the affected buildings totally destroyed, followed by Paracatu de Baixo (40% of the buildings hit were destroyed). A total of 21.1 km of rural roads, 12 bridges/passages and the small hydroelectric plant of Bicas were also damaged.

Fig. 3. Buildings affected by the Fundão tailings dam: (A) District of Bento Rodrigues, Mariana and (B) Urban area of the municipality of Barra Longa.

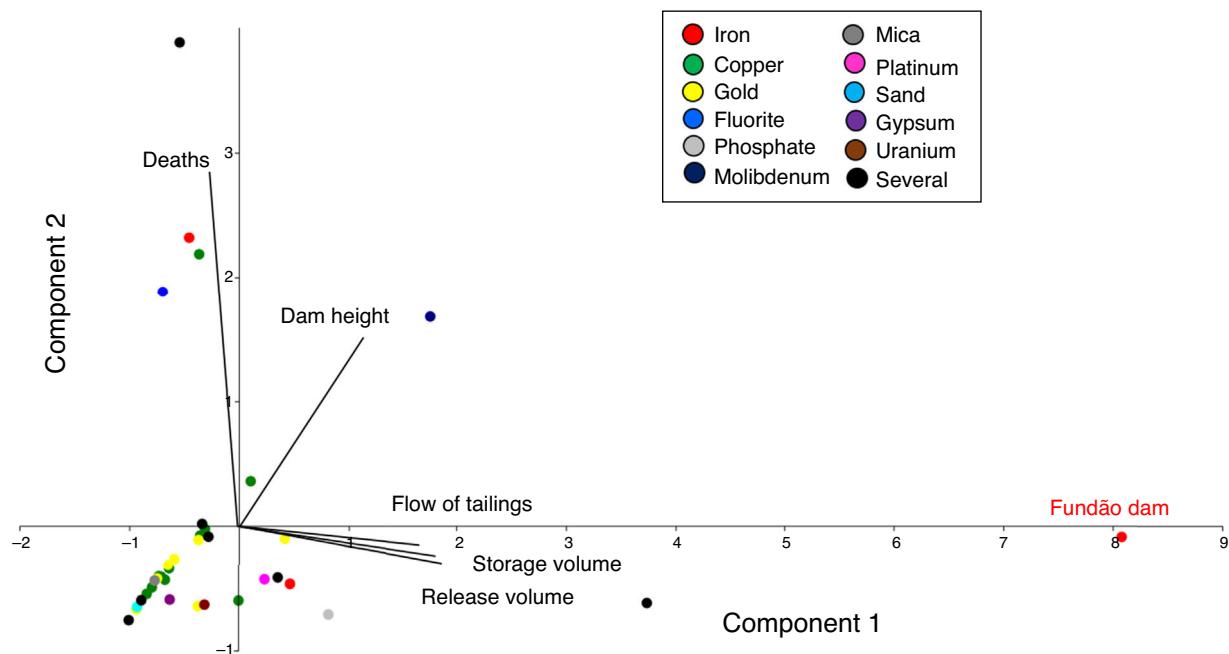
Fig. 4. Distribution pattern of 36 cases of dams disasters (colors identify the types of tailings, according to the processed ore) based on structural characteristics, distance and volume of tailing releases, and deaths by Principal components analysis. See Table S1 for details of 36 cases.

We used principal components analysis (PCA) to understand the distribution pattern of the dams based on structural characteristics and the main damage caused by such collapses (Table S1, Fig. 4). This study used information from about 36 cases of collapses (12% of global cases), which presented data related to the parameters: dam height, storage volume, released volume, tailings flow distance and deaths. The first two variables are technical characteristics related to the national dam safety policies (Brasil, 2010) for risk potential assessment, and the other variables represent the extent of effective damage (Azam and Li, 2010; Kossoff et al., 2014).

The first two axes of the PCA explained 53.8% and 21.9% of the variation, respectively. The variables that best explained the

distribution of data in component 1 were released volume (0.96), storage volume (0.86) and tailings flow distance (0.83). The analysis indicates that most collapses are related to copper mining (11 dams), gold (7 dams) and iron mining (3 dams). Similar features keep most collapses grouped in the scatter plot (Fig. 4).
